Re: Environmental Incident
Your Ref. 1272 Order No. 7-8811
White River Texaco Service Station
I-91 & Route 5
White River Junction, Vermont
CEA Ref. File #2724-88

CLOSURE REPORT
TEXACO SERVICE STATION
ROUTE 5
WHITE RIVER JCT, VERMONT

PREPARED BY
CORPORATE ENVIRONMENTAL ADVISORS, INCORPORATED
453 Center Street
Ludlow, MA 01056

Date: April 27, 1989
CEA Ref. File #2724-88

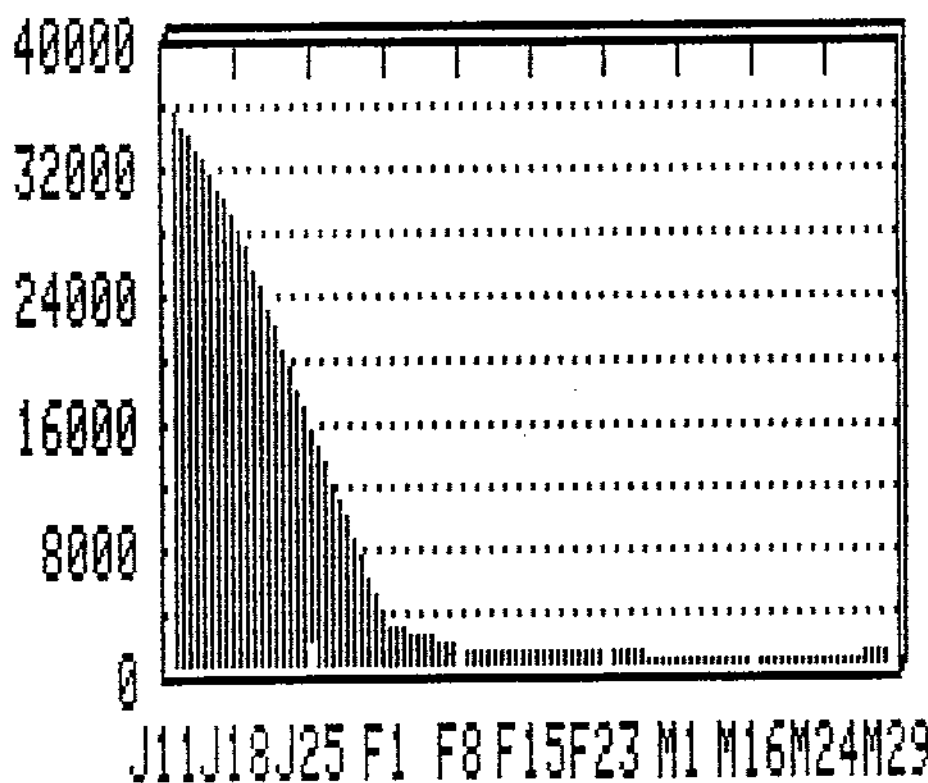
TOTAL DISSOLVED
HYDROCARBONS

stated, weekly monitoring of the system's influent, midpoint, and effluent have continued since the removal and installation of new tanks. Following are graphs depicting system influent BTEX and C1-C14 values. As both graphs indicate, dissolved phase contamination within the recovery well's influent has decreased significantly since system startup.

In addition, dissolved phase contaminants within the recovery well influent have shown a dramatic decrease relative to initial system startup values. This decrease, and analytical results of dissolved phase contaminants within the site's groundwaters, indicate a majority of the contamination has been removed. Therefore, based primarily on the absence of floating phase contamination within any of the site's monitoring wells or recovery well over the past two month period, a request is being made to terminate remedial operations on the site and removed associated equipment. In addition, a recommendation is made to continue quarterly sampling and gauging of all on-site monitoring wells and the recovery well over a one (1) year period. All gauging and analytical results will be forwarded to the Department of Environmental Conservation.
